## Macondo Well-Deepwater Horizon Blowout: Lessons for Offshore Drilling Safety

# Macondo Well *Deepwater Horizon* Blowout

LESSONS FOR IMPROVING  
OFFSHORE DRILLING SAFETY

Committee on the Analysis of Causes of the  
*Deepwater Horizon* Explosion, Fire, and Oil Spill to  
Identify Measures to Prevent Similar Accidents in the Future

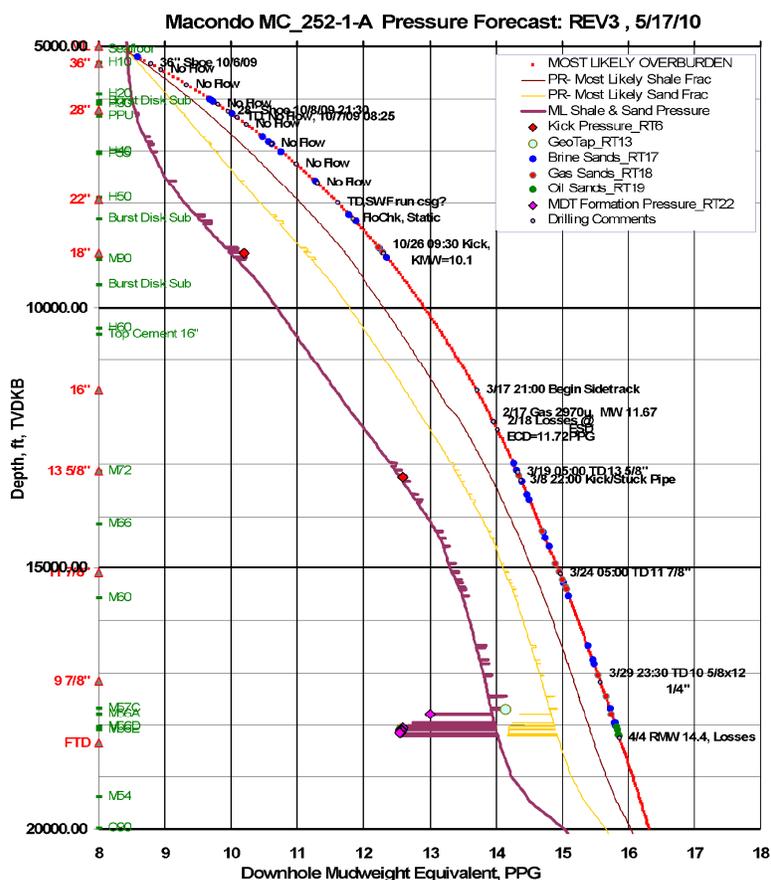
2. In the course of drilling at 13,250 feet, a kick occurred, and the lower annular blowout preventer (BOP) was closed in response. During well control operations, the drill string became stuck and was severed at 12,147 feet. The drill string and hole below 12,147 feet were abandoned, and subsequent well drilling deviated slightly to go around the abandoned materials left in the original hole. The  $13\frac{5}{8}$ -inch liner was run at 13,145 feet, which was shallower than planned, to allow the well to be drilled safely past the higher-pressure reservoir that had been encountered. The  $11\frac{7}{8}$ -inch liner was used at 15,103 feet to seal the reservoir and allow for the use of higher mud weights than had been anticipated. Mud weight was to be kept between the curves for pore pressure and fracture pressure, as shown in Figure 2-3.

**FIGURE 2-3** The four curves (moving from right to left) represent overburden stress, fracture gradients in the shale and sands, and pore pressure in the Macondo well. Depth and diameter values on the y-axis correspond to the final well bore architecture shown in Figure 2-2. The equivalent mud weight (EMW), expressed in pounds per gallon (ppg), must be higher than the pore pressure to avoid flow from the well and lower than the fracture gradient to prevent accidental hydraulic fracturing. Note the small separation between the values at depths below 18,000 feet. Source: BP unpublished report, July 26, 2010.<sup>3</sup> Reprinted with permission, BP.

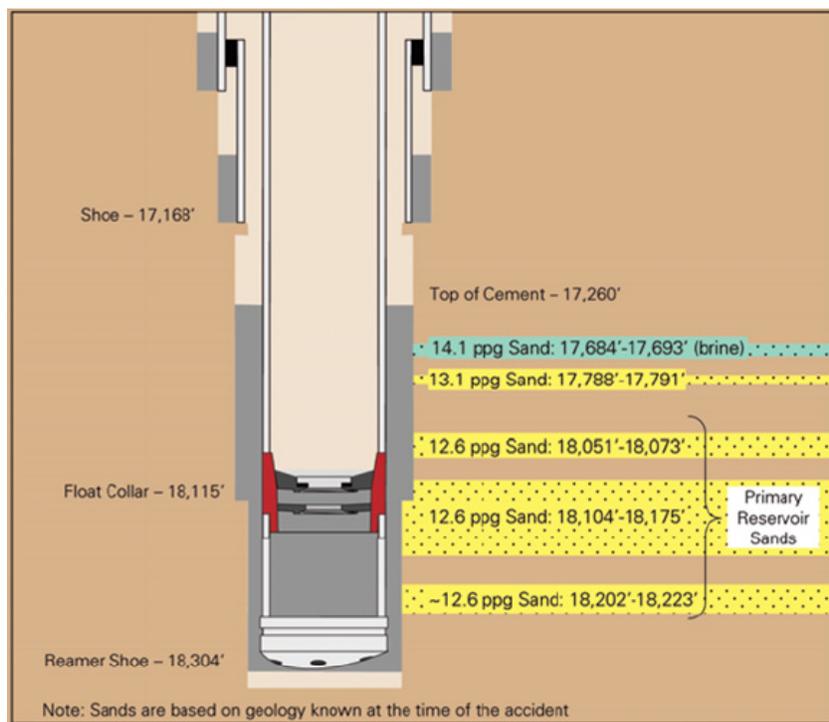
tion report, the well analysis indicated that there were in fact several reservoirs open in the wellbore with decreasing pore pressure with depth, as shown in Figure 2-4. The hydrocarbon reservoirs had pore pressures equivalent to a range of 12.6 to 13.1 ppg. A reservoir containing salt water that had a pore pressure equivalent to 14.1 ppg was also exposed in the wellbore. As discussed below, the difference between the mud weight needed to prevent flow of salt water and the mud weight above which reservoir fracture could occur was only 0.2 ppg. Recent reports in the press have indicated that a thin gas sand was present above the salt water bearing zone shown in Figure 2-4 and have questioned the possible contribution of this sand to the blowout. The committee has seen no evidence indicating that flow occurred upwards in the annulus between the production casing and the reservoirs (see discussion below). Also, the presence of the high-pressure salt water sand created the same completion problem referenced above as would have been created by the presence of a high-pressure gas sand. Therefore, the presence or absence of the gas sand is expected to have had no material effect on the cause of the blowout.

**FIGURE 2-4** Variation of pore pressure in the open hole section of the Macondo well expressed in pounds per gallon. Source: BP 2010, p. 54. Reprinted with permission; copyright 2010, BP.

To continue drilling to the planned final depth of 19,650 feet, the reservoirs that had been discovered with decreasing pore and fracture pressures with depth (Figure 2-4) were to be sealed with the  $9\frac{7}{8}$ - × 7-inch combination casing string and cement. However, because the hole diameter that could be drilled below the 7-inch casing was considered too small to be practical, the well was terminated at 18,360 feet.

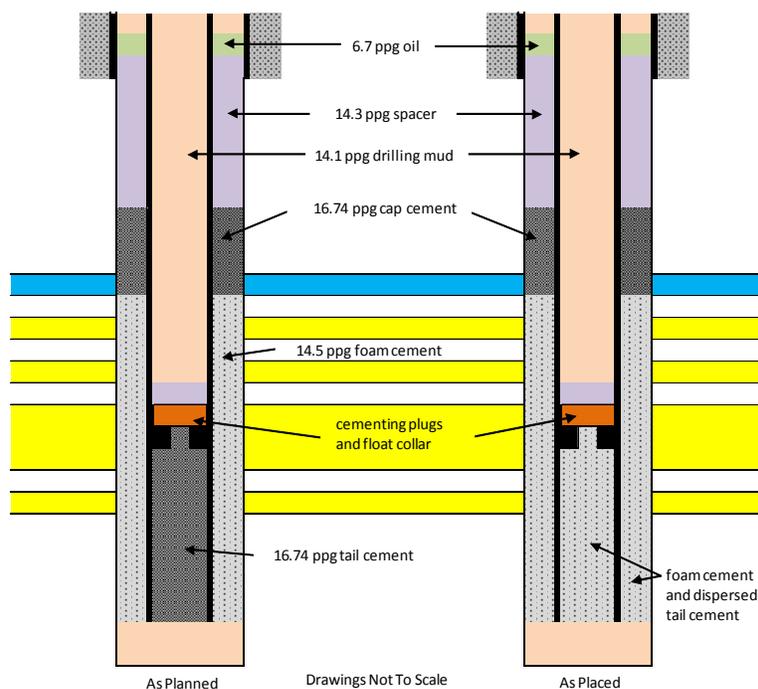
<sup>6</sup>The bottom section of the casing in the Macondo well, called the “shoe track,” was a section of casing about 189 feet long with a reamer-guide shoe at the bottom and a dual-flapper float collar on top.

**FIGURE 2-5** Planned cement location and likely cement location after pumping. Source: Committee.

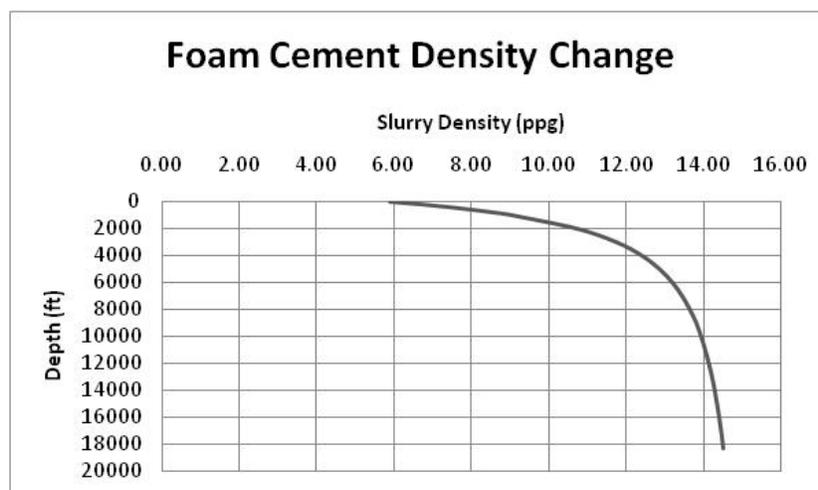
To make a foamed cement slurry that has a density of 14.5 ppg at the bottom of the well, the foam quality<sup>7</sup> had to be 17.4 percent at bottom hole conditions of 245°F and 13,321 psi (see Appendix D for the calculations).<sup>8</sup> At the surface, where the conditions in the mixer were about 600 psi and 60°F, the foam quality had to be 66 percent, producing a foamed slurry of about 6 ppg, to allow for the substantial compression and heating that were to occur as the foam was pumped to the bottom of the well. (For reference, freshwater has a density of 8.33 ppg.) Figure 2-6 shows the calculated foam density versus depth.

FIGURE 2-6 Calculated foam density versus depth during pumping. Source: Committee.

Once mixed, the foam was immediately pumped into the well, where pressure and temperature increased with depth, changing the foam quality and slurry density all the while. The shear associated with fluid movement down the inside of the pipe would act to break up large bubbles, which immediately reform as smaller bubbles so long as agitation is taking place.

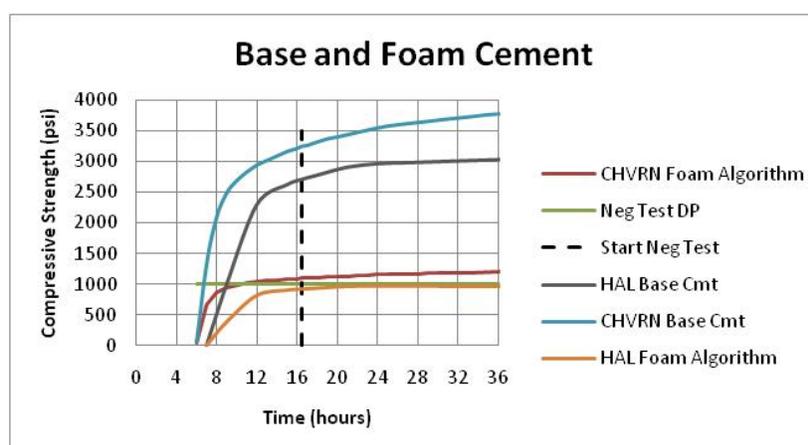
**FIGURE 2-7** Uncontaminated cement compressive strength tests (DP = differential pressure). Source: Committee.

The curves for the two foamed cements are not from direct measurement but assume that the foamed cement compressive strength is reduced according to the foam protocol used in the Chevron test software (by a factor of approximately 35 percent).

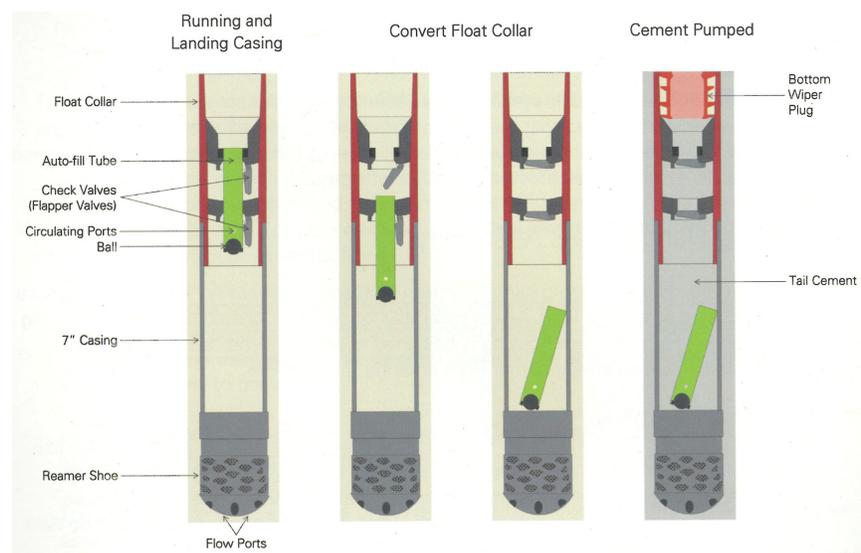
**FIGURE 2-8** Float collar with flapper valves and differential fill tube. Source: BP 2010, p. 71. Reprinted with permission; copyright 2010, BP.

Once the casing was in place in the Macondo well, initial circulation could not be established until 3,142 psi of pump pressure was applied. This suggests that the shoe track was plugged with foreign material when it was run into the well. The practice of allowing mud to fill the casing by flowing up through the differential fill tube is a time-saving step that would not be needed if the casing were filled with mud from the top as it is run, a much slower process but one that reduces the possibility of debris entering the casing.

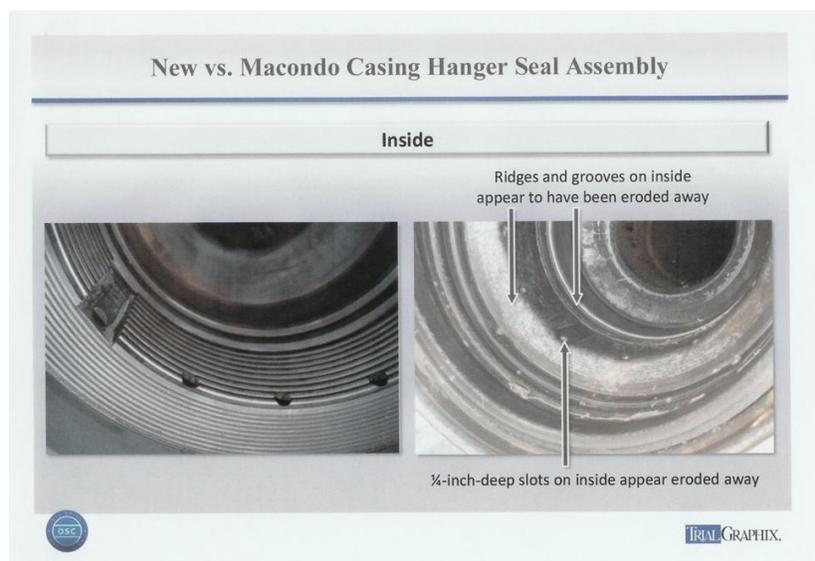
**FIGURE 2-9** View inside casing hanger. Source: Presidential Commission 2010, Slide 118.

This type of circulation was not done completely at the Macondo well to reduce the possibility of exceeding the fracture pressure because of unforeseen pressure surges. This decision by BP also cut down on the time spent circulating. Failure to perform the minimum circulation could leave debris inside the casing or annulus that may plug it. Any hydrocarbons in the annulus may result in a well control problem.

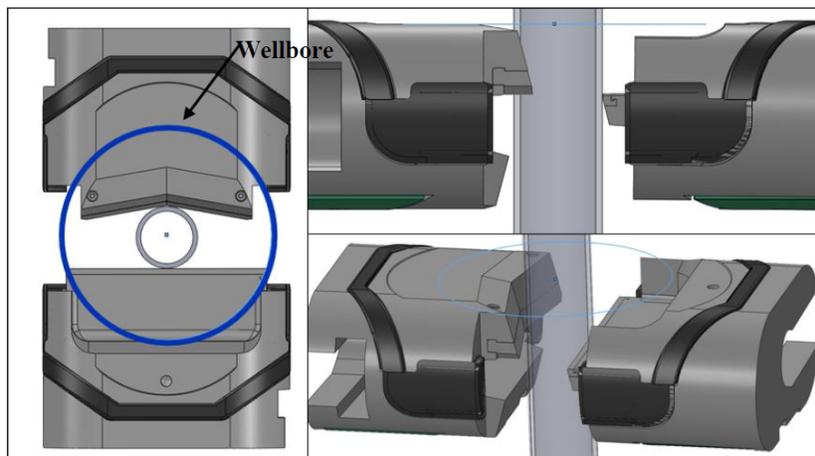
The BSR was the uppermost of the five rams of the BOP stack and is shown for nominal operation in Figure 3-2. A BSR is like a massive metal scissors with two opposing blades that are designed to slice through the drill pipe as the blades pass by each other, as shown in Figure 3-3, and seal the well. The design intent was that, when the two blades of the “scissors” passed by each other and fully penetrated into the “side packers” on the other side, the seal

across the BOP bore was to be effected and thus seal off the entire throat of the BOP. The BSR was, by design, a device of last resort in a hierarchy of well control strategies: when all else failed, the BSR was to slice the drill pipe and seal the well. Even if no drill pipe was present in the BOP system, the BSR was designed to seal the well when the “scissor blades” passed by each other and into the side packers.

**FIGURE 3-2** Sketch of intended nominal operation of BSR in the Macondo well. Source: DNV 2011a, I, p. 155. Reprinted with permission; copyright 2011, DNV.

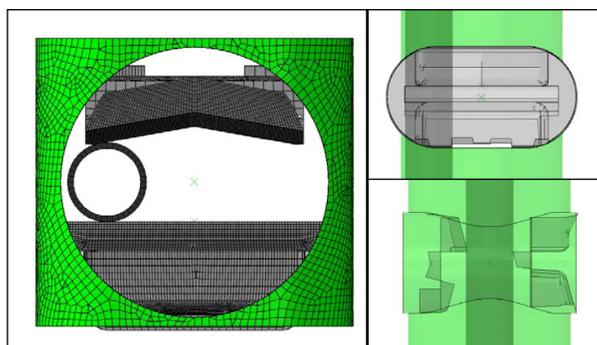
**FIGURE 3-5** Finite element analysis model of BSR blade surfaces and off-center drill pipe. Source: DNV 2011b, p. 15. Reprinted with permission; copyright 2011, DNV.

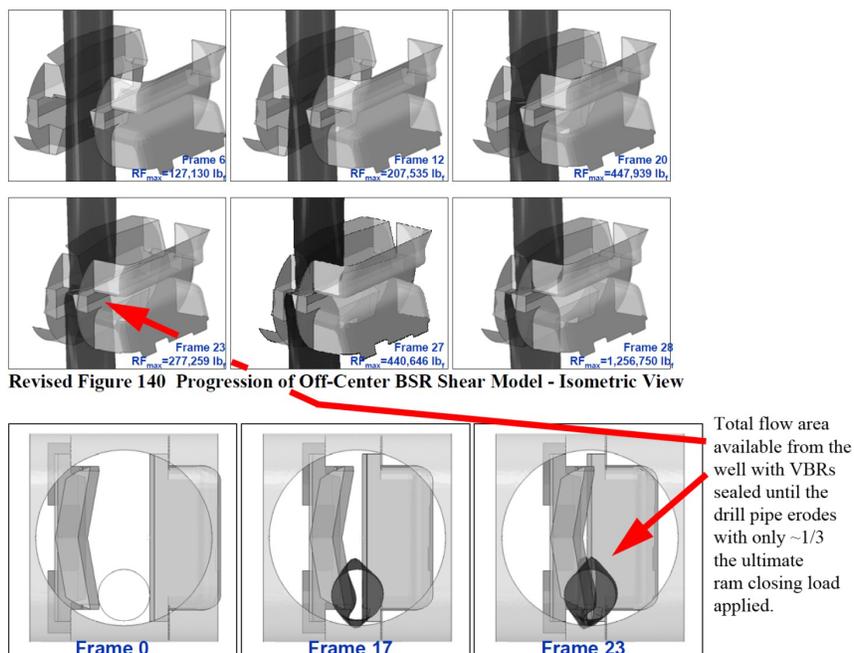
Revised Figure 140 Progression of Off-Center BSR Shear Model - Isometric View

**FIGURE 3-6** Progression of off-center BSR shear model, isometric view (*top*) and top view showing deformation of drill pipe outside of shearing blade surfaces (*bottom*). Source: DNV 2011b, p. 17. Reprinted with permission; copyright 2011, DNV.
