Report

PETROLEUMSTILSYNET

Investigation of gas blowout on Snorre A, Well 34/7-P31A, 28 November 2004

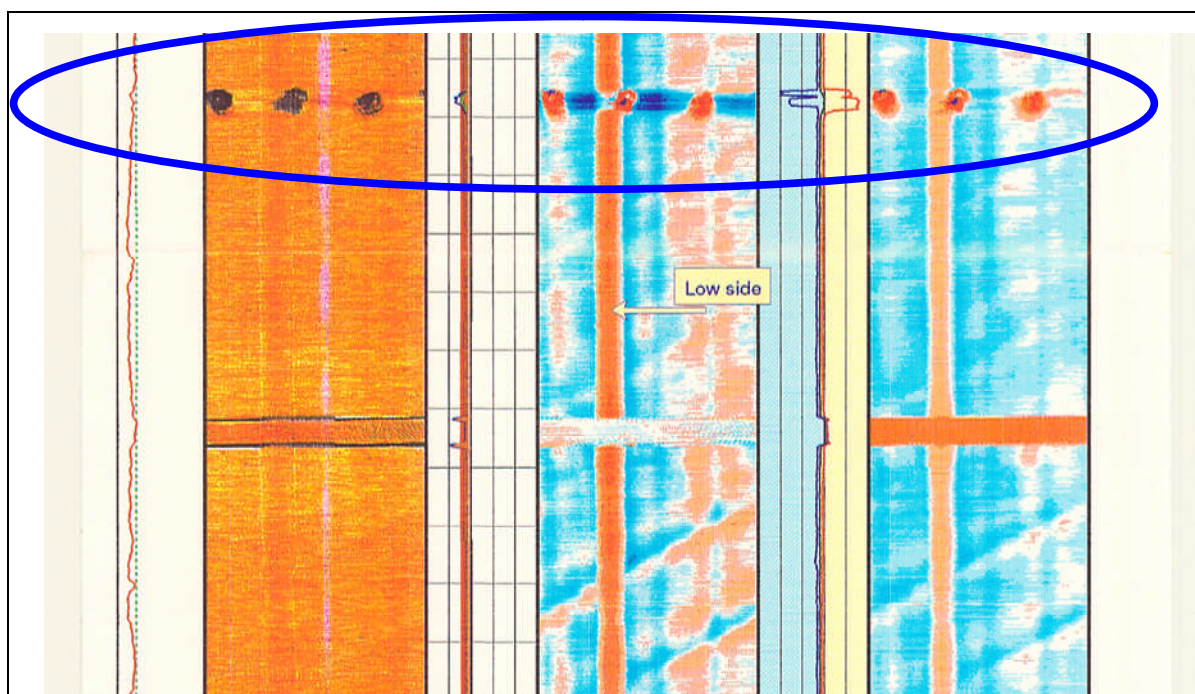
- During cementing of the 5 1/2" extension pipe in the P-31A sidetrack in 1995, the drill string got stuck. This led to a prolonged fishing and milling operation which in turn resulted in extensive casing wear in the 9 5/8" casing. After subsequent clean-up, logging/pressure testing showed that 2-3 holes had been flushed with high pressure washing tools at 1561 mMD (meters measured depth) (see Figure 1).³

Figure 1. USIT/CBL log from 1995 showing damage to the 9 5/8" casing

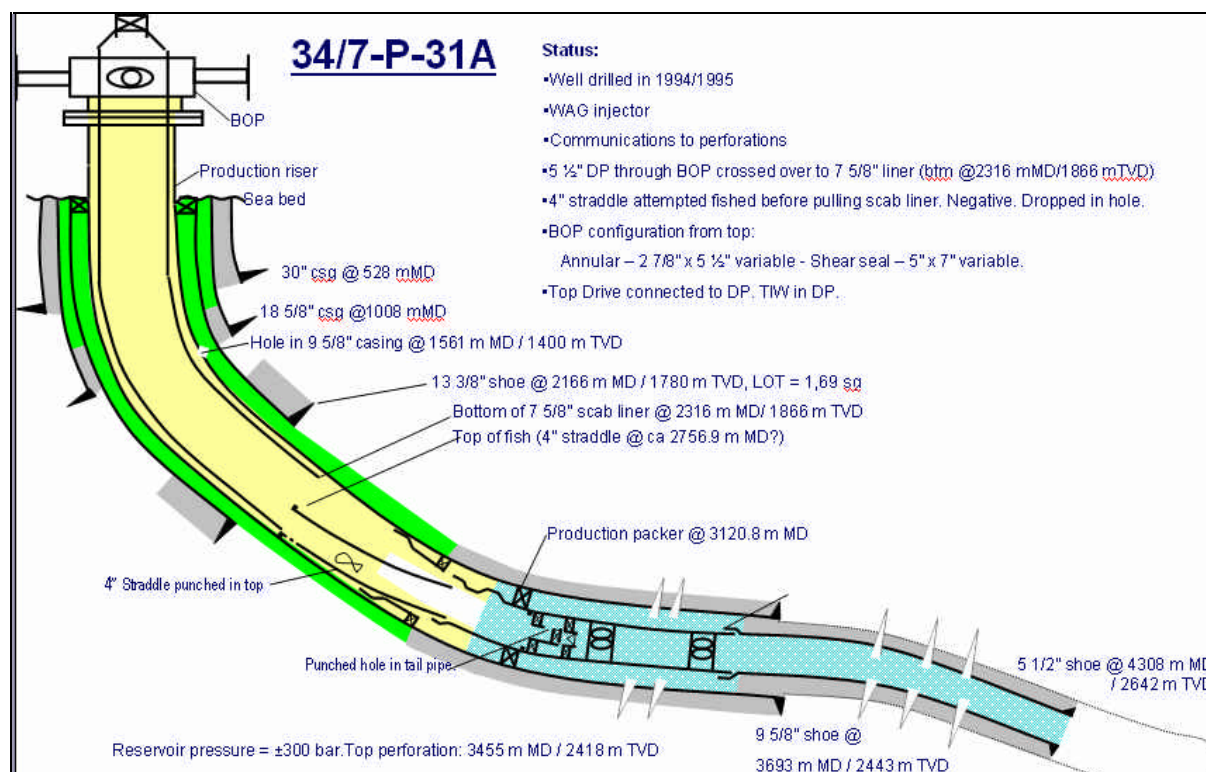
The well was considered to be "complex". This was related to (see Figure 2):

- Factors which give the well reduced integrity (corrosion, leaks).
- Unconventional well completion with a great many small completion elements.
- Additional completion elements installed in the well in connection with repairs (Scab-liner and straddle)
- Downhole well control valves

Figure 2. Well sketch reflecting status of well integrity prior to start-up of the well operation.

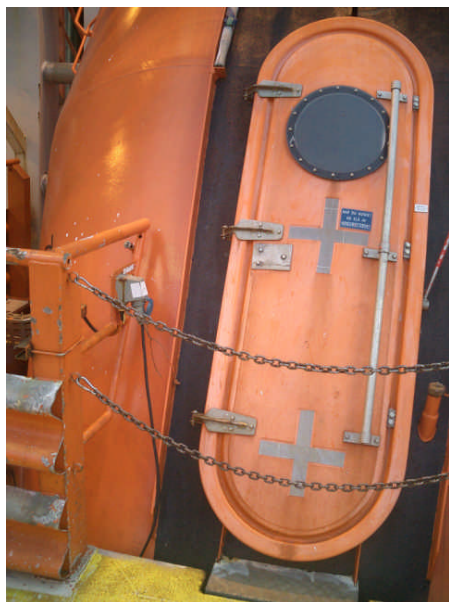
After the incident, Lifeboats 1 and 4 did not start when tested. For Lifeboat 1, this seems to be caused by air in the diesel system. For Lifeboat 4, the plug for the charging cable shall be removed when the lifeboat is boarded, see Figure 5. This means that when personnel were sitting in the lifeboat, the battery as being drained. When we switched to the spare battery, the lifeboat started. The procedure for preparing the lifeboat should be reconsidered in light of this.

Figure 5. Shows entrance to lifeboat with outlet and charging cable

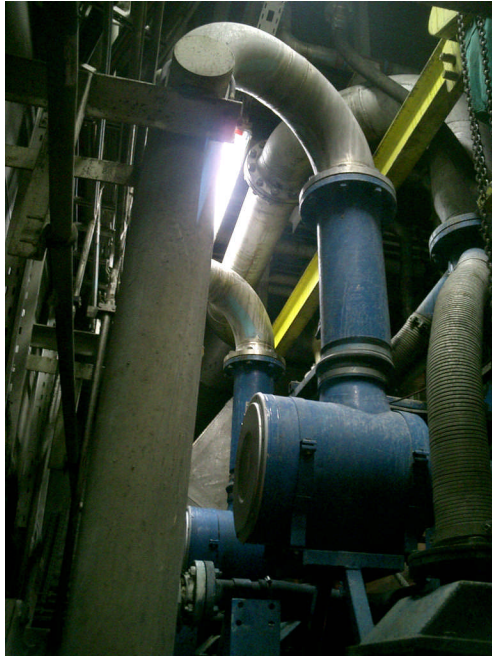
as regards sucking in gas, and the pumps could not be used. Measures to turn the air intake for the motor and ventilation in the cement room were implemented. The air intake was disconnected so that the motor could pull air from the room. At the same time, the air intake for the cement room itself was closed. In this way, the crew ensured that the cement pumps could be used later, see Figures 6 and 7.

Figure 6. Air intake for diesel motor for cement pump

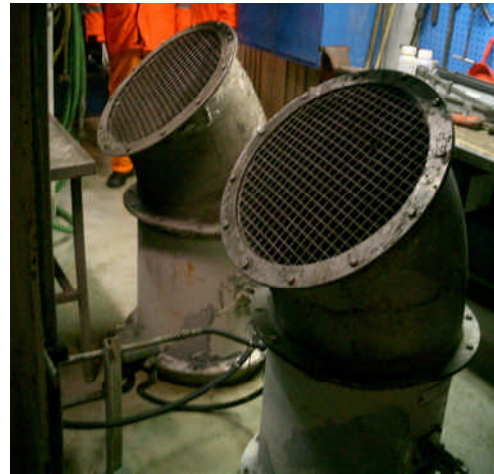
Figure 7. Air intake for cementing room

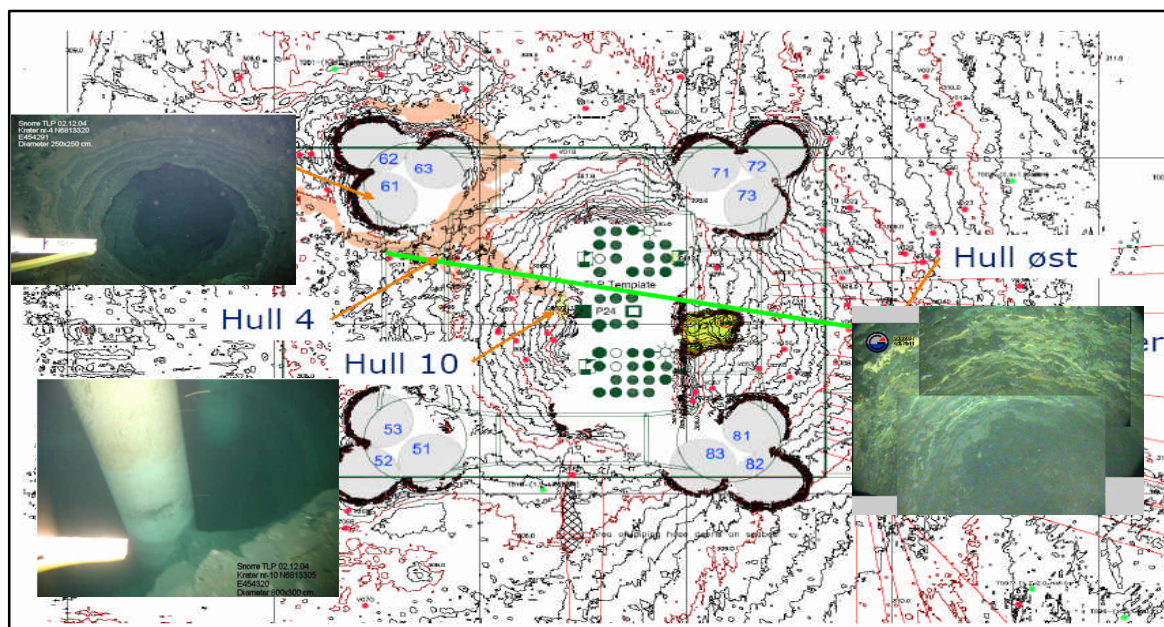
Surveys of the seabed show a crater measuring 8 x 3 meters on the west side of the well template, as well as two craters with diameters of 2.5 and 3 meters. In addition, several smaller craters have been noted towards the northwestern anchor point, while the crater with a

Figure 10. Craters on the seabed

Statoil has analyzed several potential explanations of the changes in the tension. There are several explanations that, viewed independently, could have contributed to increased tension balance error, but not to the extent observed. Therefore, we cannot rule out that a movement of the foundations on the northwestern corner have contributed to the tension balance error. A detailed inspection has been conducted of the transition between the foundation and the seabed. Based on this inspection, one cannot see signs of movement or rotation of the concrete foundation. However, it is uncertain whether it is possible to observe movements in a centimeter range. About three cubic meters of gas were drained out of the bucket foundation in the northwestern corner after the blowout. A subsequent bleed showed that no more gas had entered the foundations. The gas in the bucket foundations indicates that there may be an internal crater. The volume of gas would indicate that the crater is probably not very big. However, we cannot rule out that there was higher overpressure during the blowout than what was drained out on 6 December 2004. No cracks have been observed in the foundations. A drainage through cracks must have come from below ground level - perhaps in connection with one of the craters.
