## Macondo Well-Deepwater Horizon Blowout: Lessons for Offshore Drilling Safety

# Macondo Well *Deepwater Horizon* Blowout

LESSONS FOR IMPROVING  
OFFSHORE DRILLING SAFETY

Committee on the Analysis of Causes of the  
*Deepwater Horizon* Explosion, Fire, and Oil Spill to  
Identify Measures to Prevent Similar Accidents in the Future

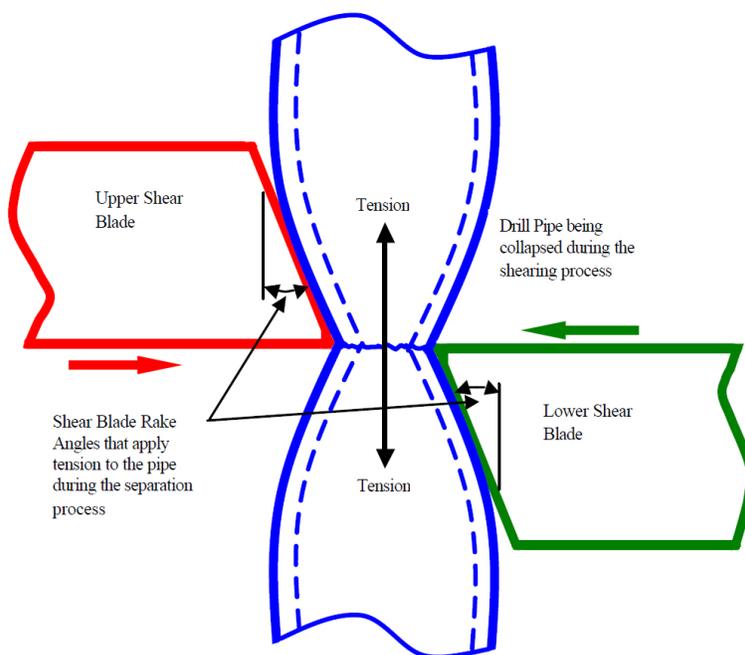
**FIGURE 3-3** Upper and lower shear blades crushing the drill pipe and beginning the shearing (or breaking) operation. Source: West Engineering Services, Inc. 2004, p. 2-2. Reprinted with permission; copyright 2004, West Engineering Services, Inc.

- In the cutting process, the shear rams collapse or mash the pipe, and as the pipe is crushed, the blade angle pulls the metal into tension and breaks it in a tensile mode of failure (Figure 3-3). Depending on the ram blade design, the blade can flatten the pipe to a great extent, which in turn can prevent the ram from closing completely and sealing even if the pipe is centered.

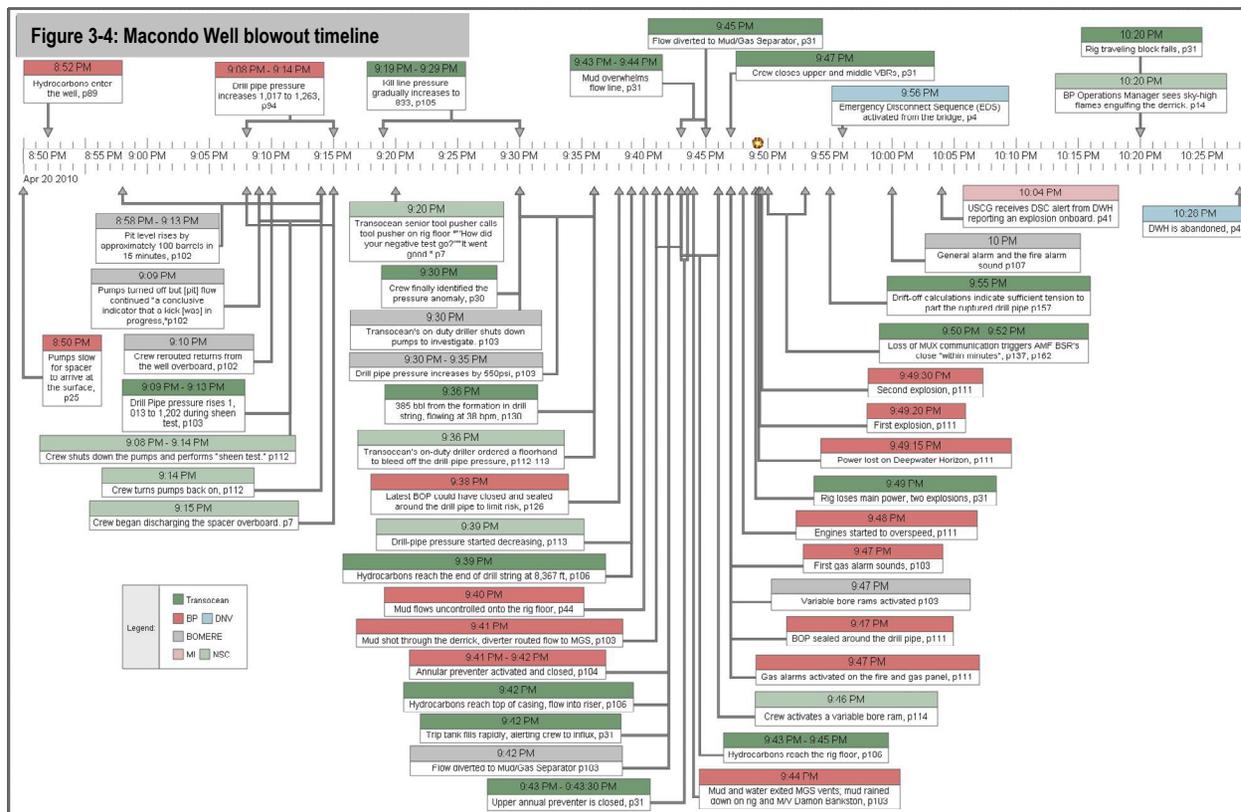
FIGURE 3-4 Macondo well blowout timeline. Source: Committee.

***Summary Finding 3.1:*** The loss of well control was not noted until more than 50 minutes after hydrocarbon flow from the formation started (see timeline in Figure 3-4), and attempts to regain control by using the BOP were unsuccessful. The BSR failed to sever the drill pipe and seal the well properly, and the EDS failed to separate the lower marine riser and the *Deepwater Horizon* from the well.

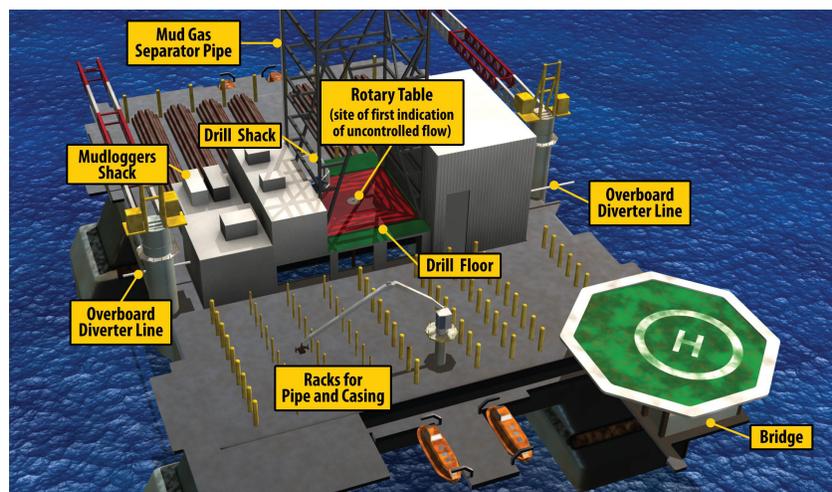
The only path, other than straight up through the derrick or through the MGS system vents, through which uncontrolled hydrocarbon flow could have been directed is through 14-inch diverter lines, which were positioned to send the flow overboard at about derrick floor level (see Figure 4-2). Testimony cited above indicates that this did not occur, and why there was no hydrocarbon flow along that path remains an unresolved question.<sup>10</sup> According to BP's analysis, the overboard diverter flow of hydrocarbons might have delayed the formation of the explosive cloud that surrounded the rig (BP 2010, 128).

**FIGURE 4-2** Illustration of the main deck of the *Deepwater Horizon*. The rig crew could send fluids from the well overboard through the overboard diverter lines. Alternatively, the crew could route flow from the well to an MGS pipe and vent hydrocarbon gas before sending the mud to the mud pits (not shown). Source: Chief Counsel 2011, p. 27.
