Report

PETROLEUMSTILSYNET

Investigation of gas blowout on Snorre A, Well 34/7-P31A, 28 November 2004

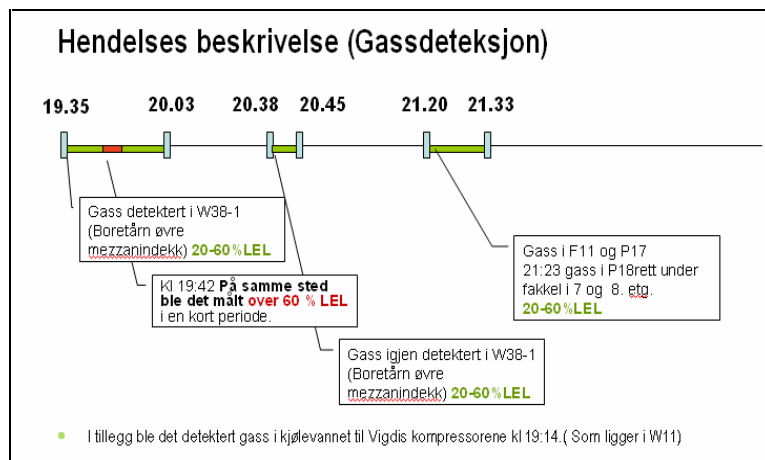
Figure 3. Timeline for gas detection on board

A transcript of the incident log from the CCR shows that gas was detected in Module W07 (Room W 38-1, deck below the drill floor) and externally on Module W11, (cellar deck west) and in the P17 and P18 modules (the Vigdis module which is located near the flare on the 7th and 8th floors). Figures 3 and 4 show a time line and location for gas detection on the facility.

Gas detected again in W38-1 (drilling derrick upper mezzanine deck), 20-60% LEL

* Gas was also detected in the cooling water to the Vigdis compressors at 1914 hrs (located in W11)
